EXHIBIT 8

Part 2

Figure 14. Comparison of damage to subject pipe vs. damage induced by the December 3, 2012 testing.

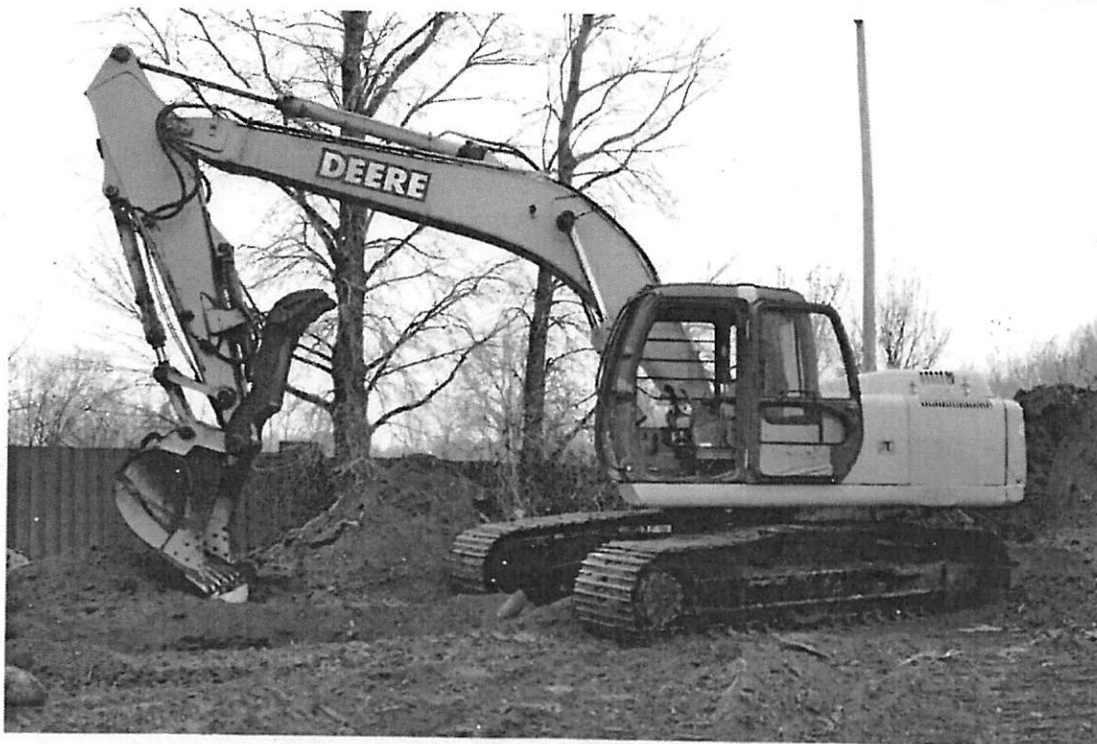
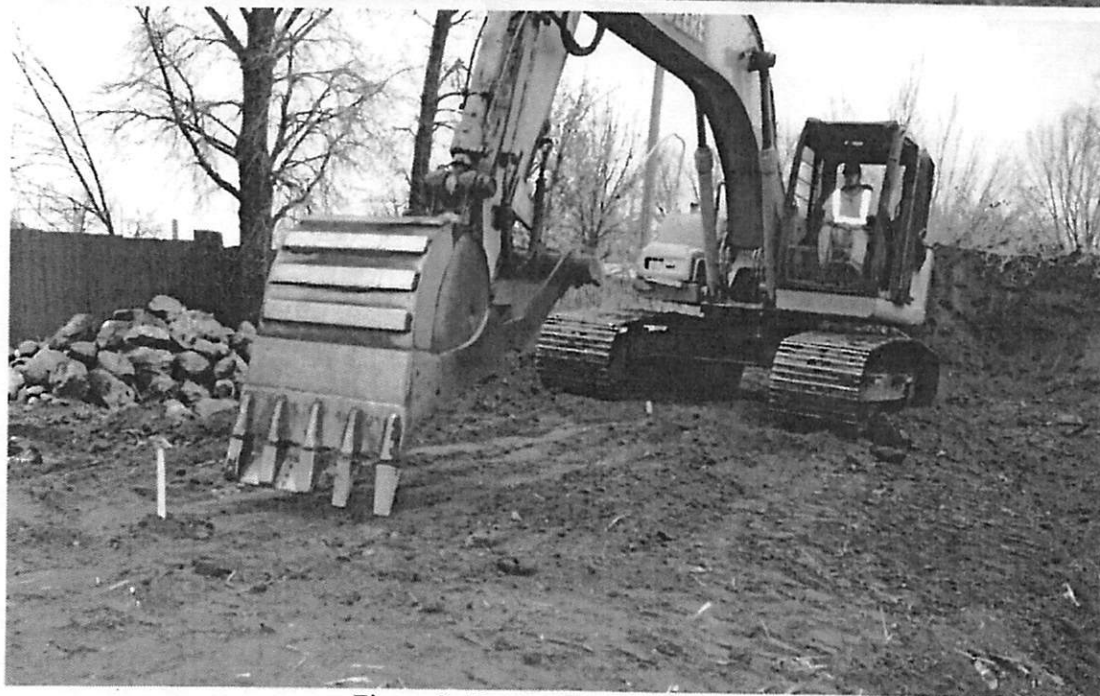
Figure 3. Excavator used in testing.

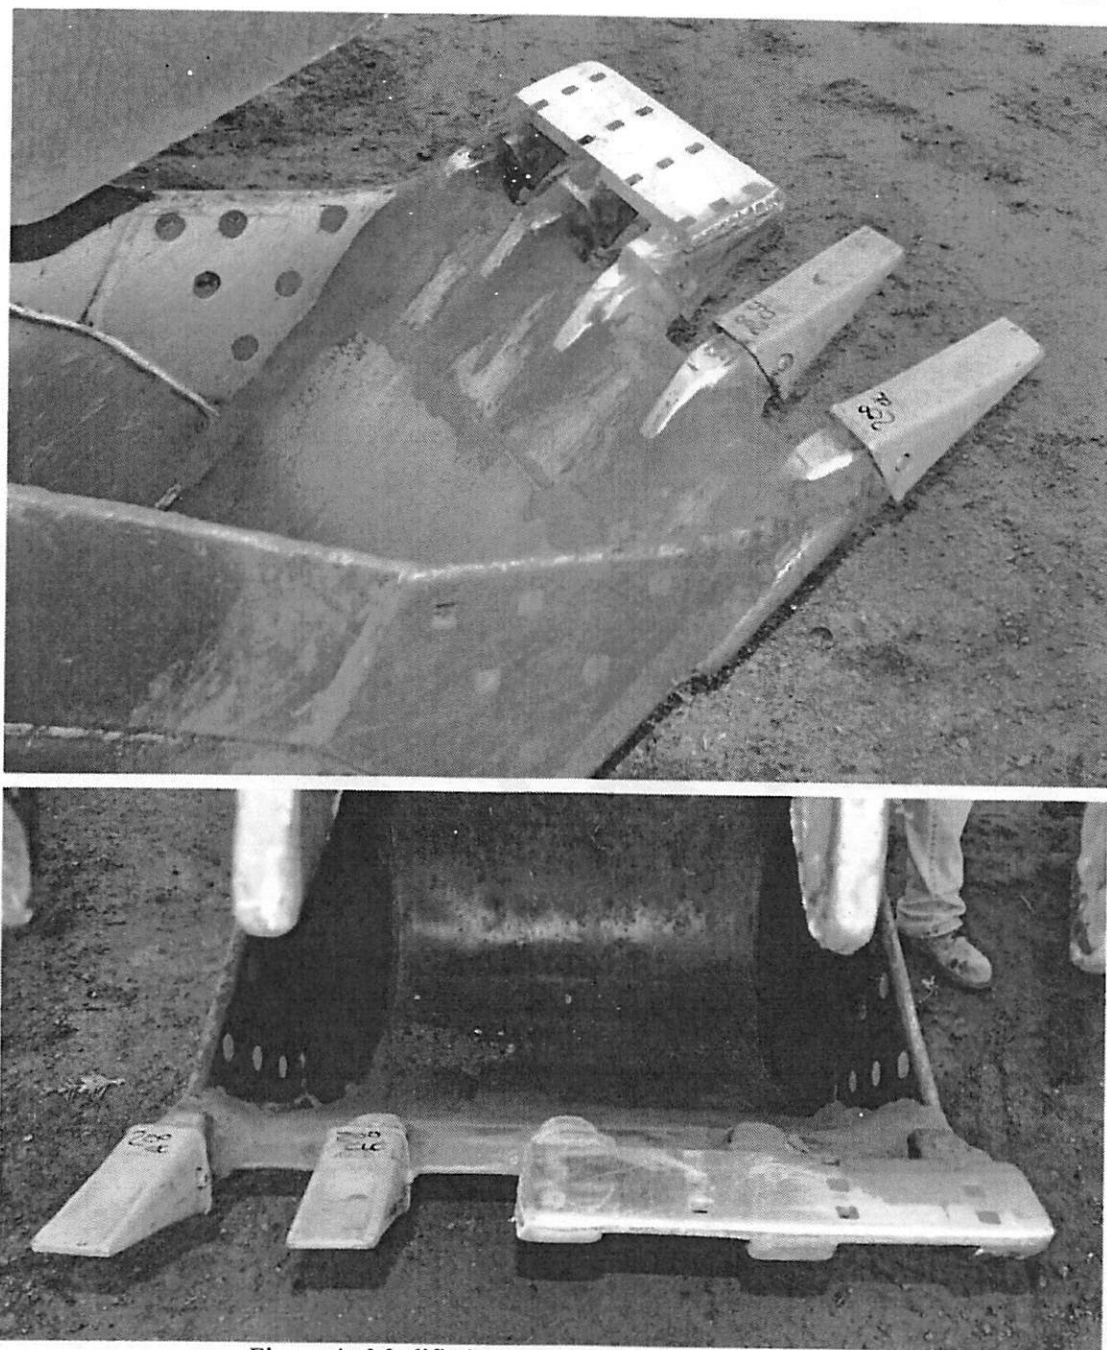
Figure 4. Modified excavator bucket used in testing.

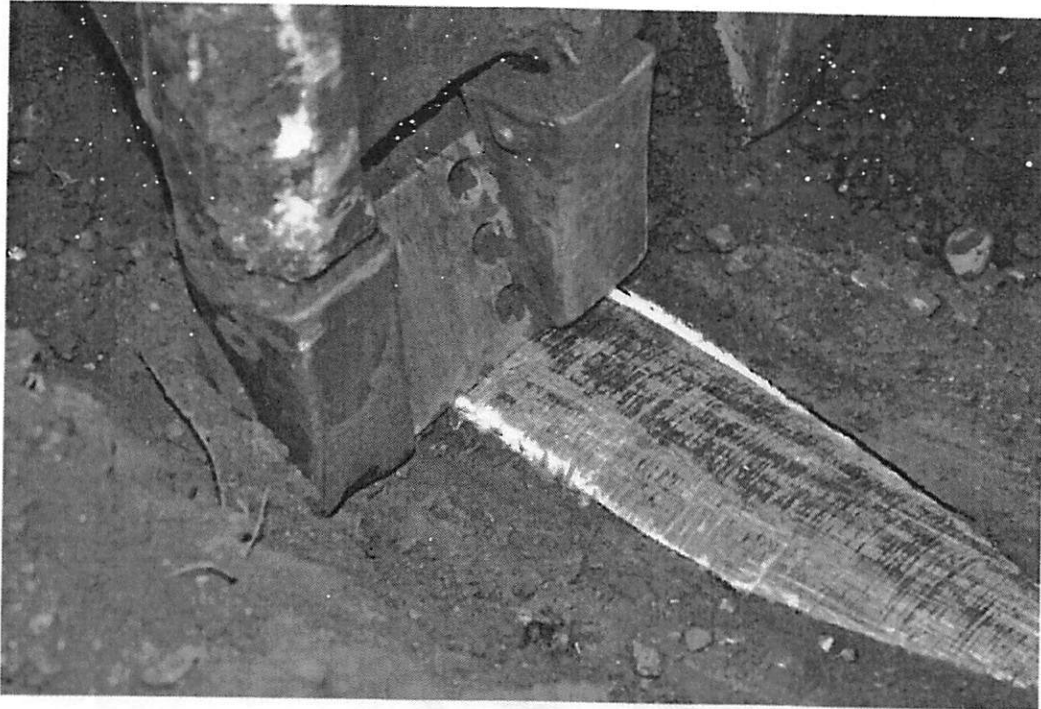
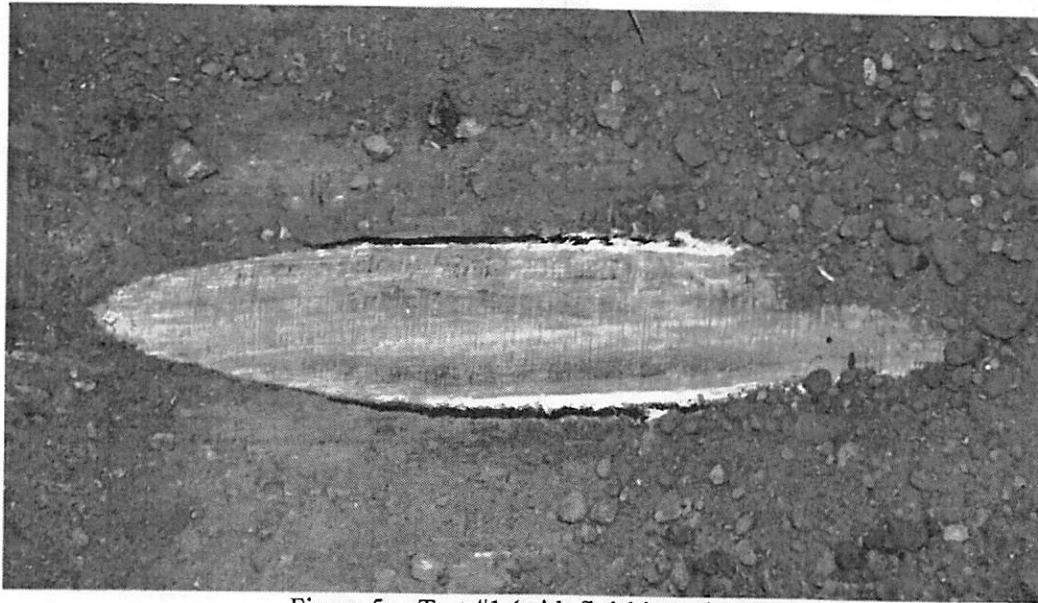
Figure 5a. Test #1 (with finishing edge).

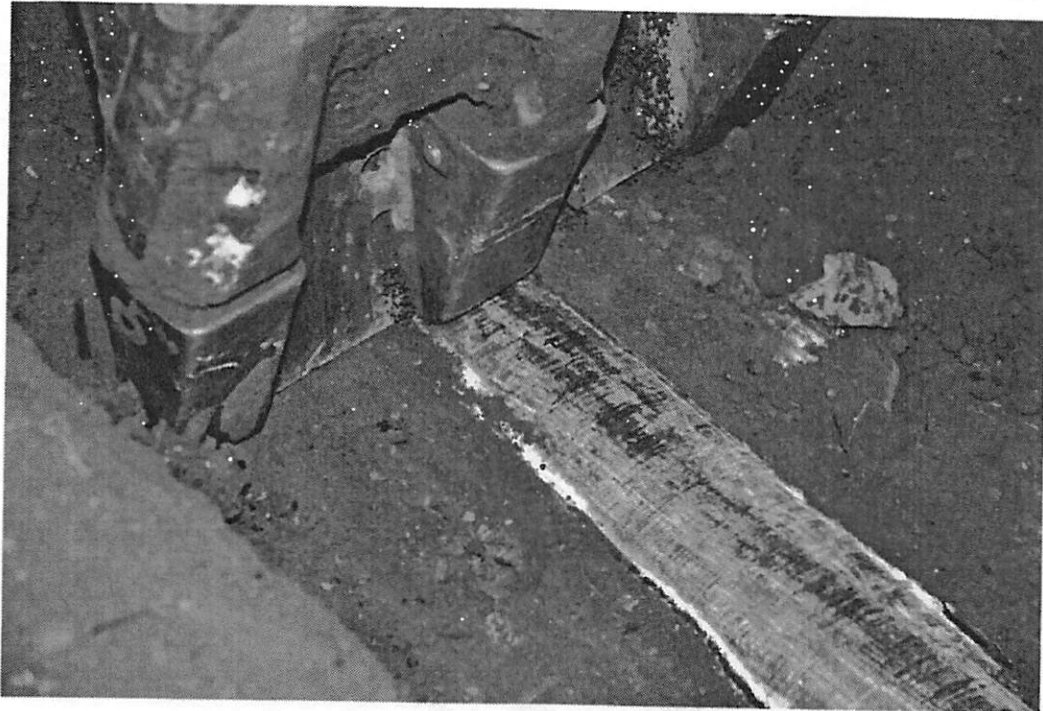
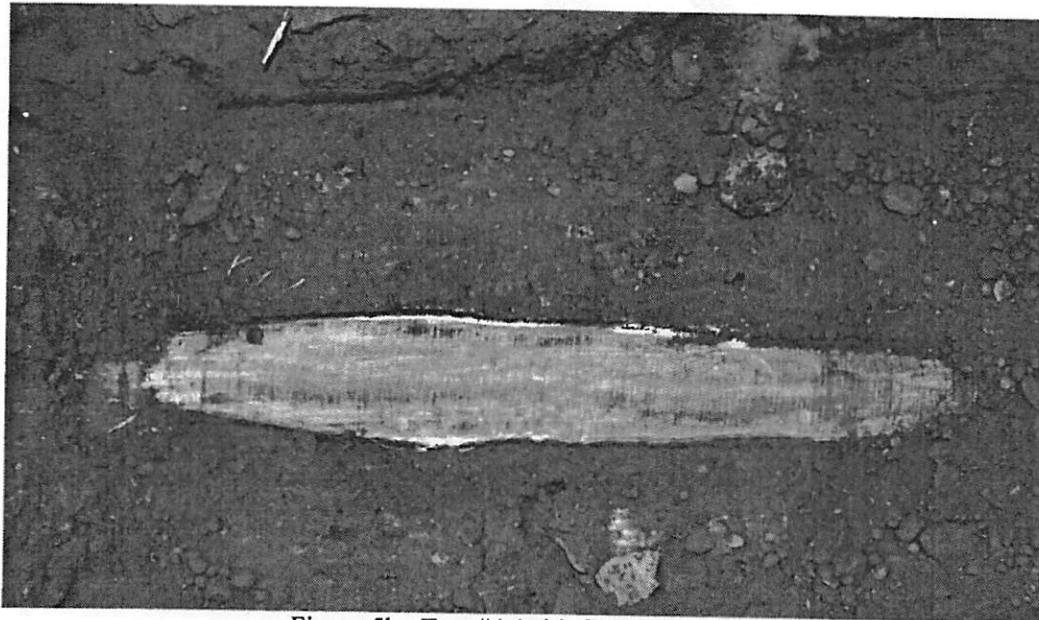
Figure 5b. Test #4 (with finishing edge).

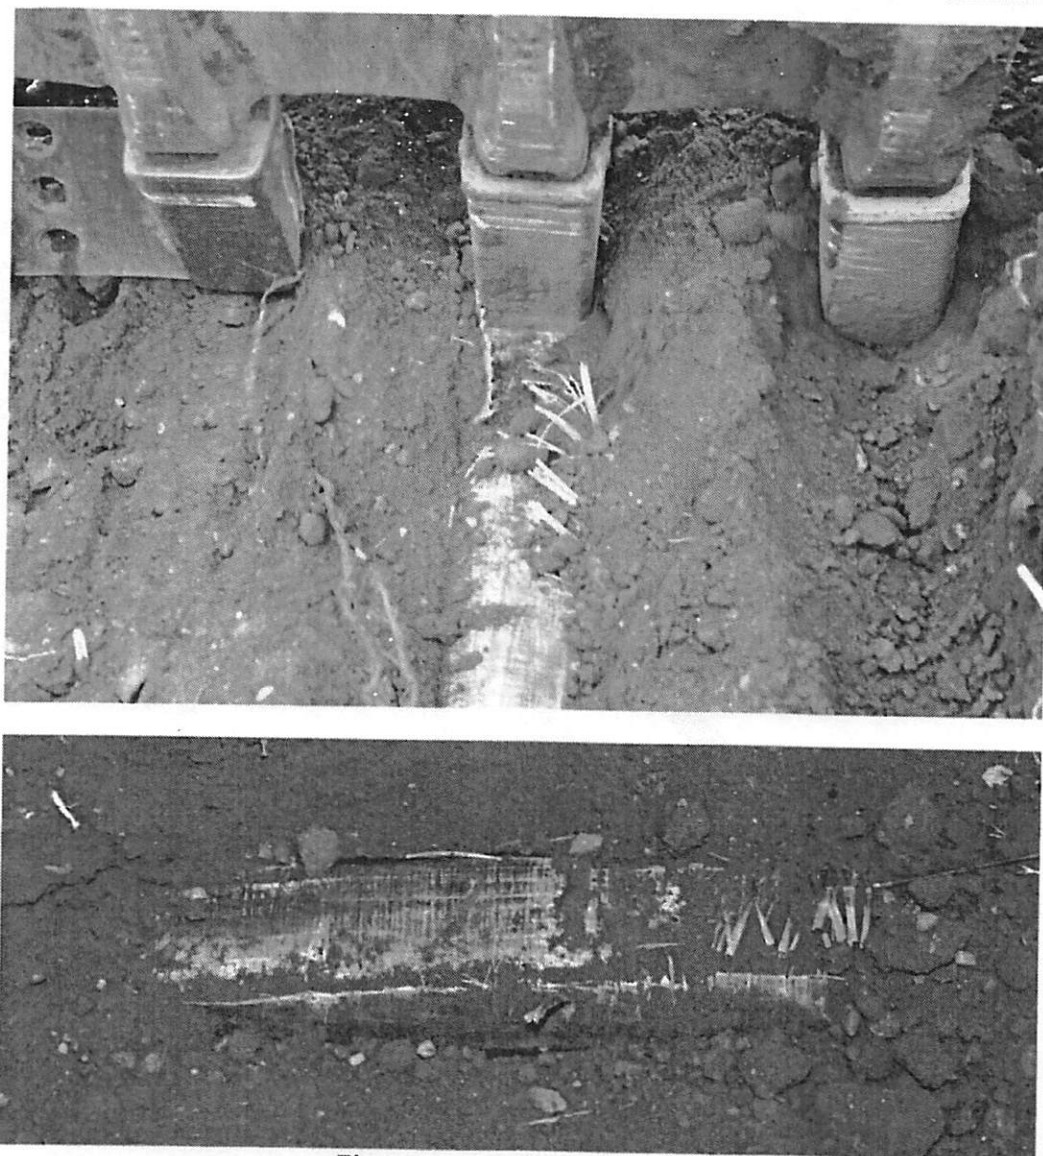
Figure 5c. Test #2 (with tooth).

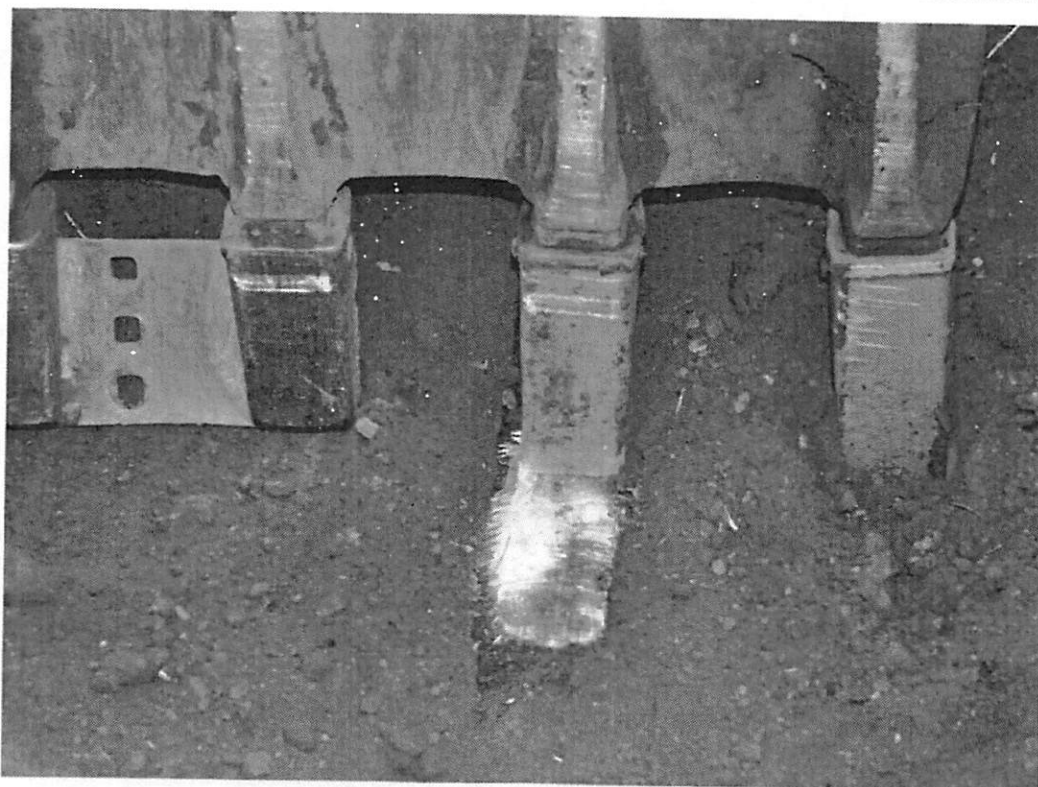
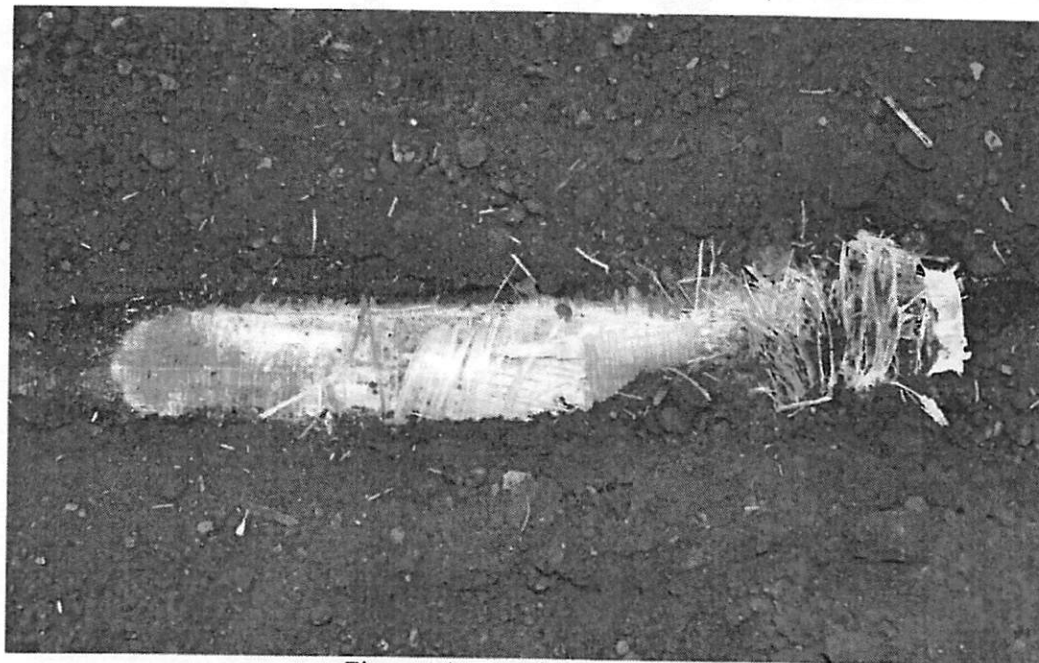
Figure 5d. Test #3 (with tooth).

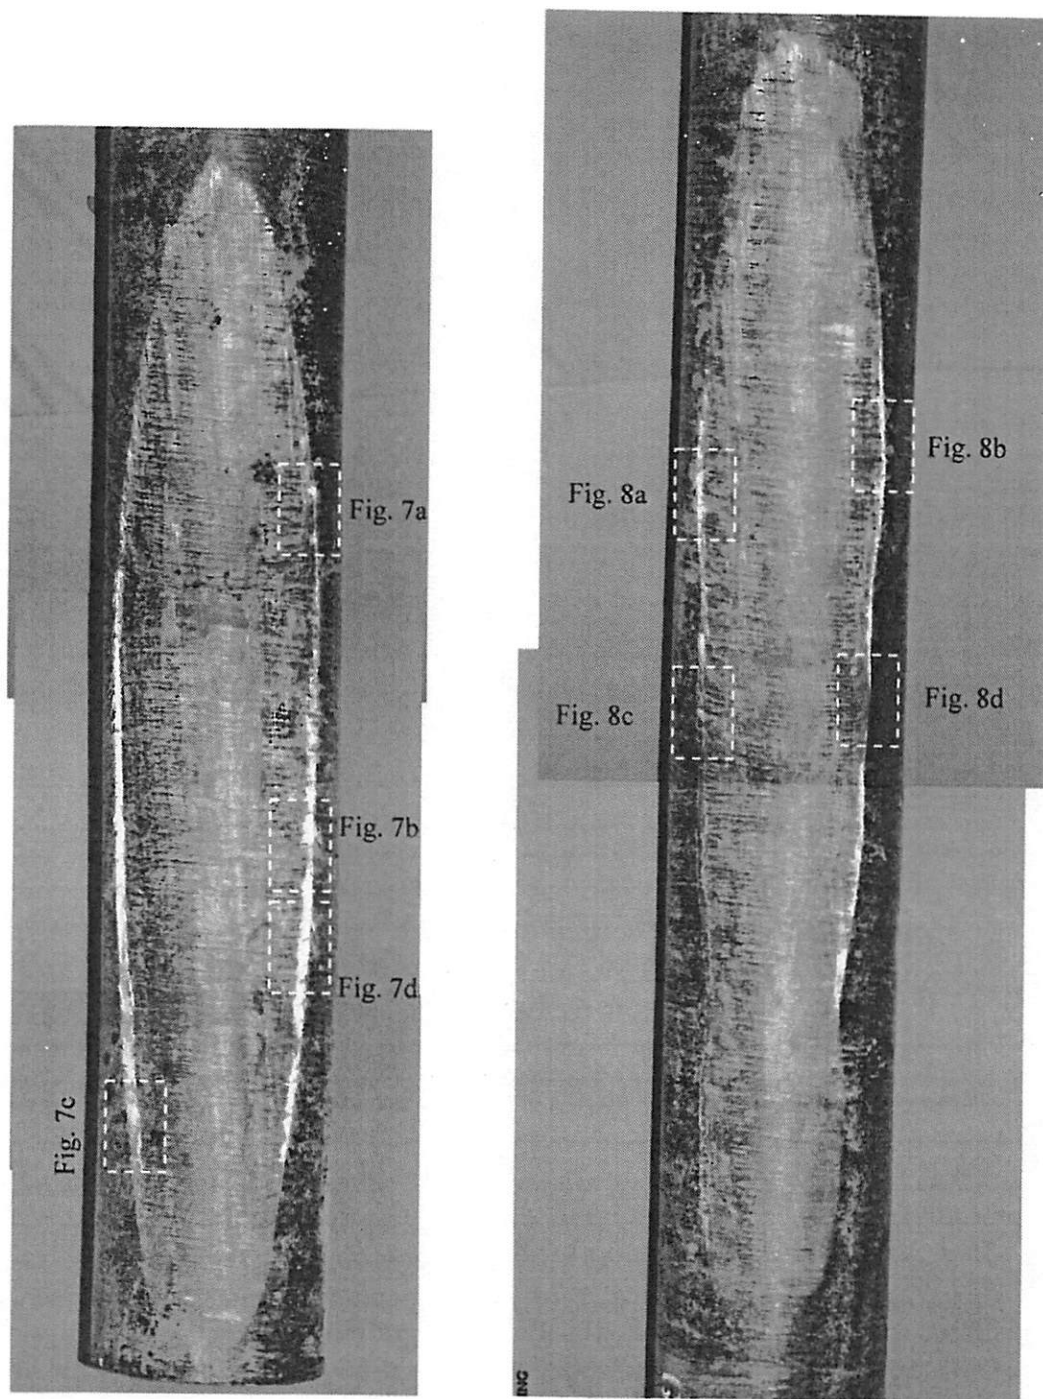
Figure 6. Damage induced by Finishing Edge (Tests #1 and 4).

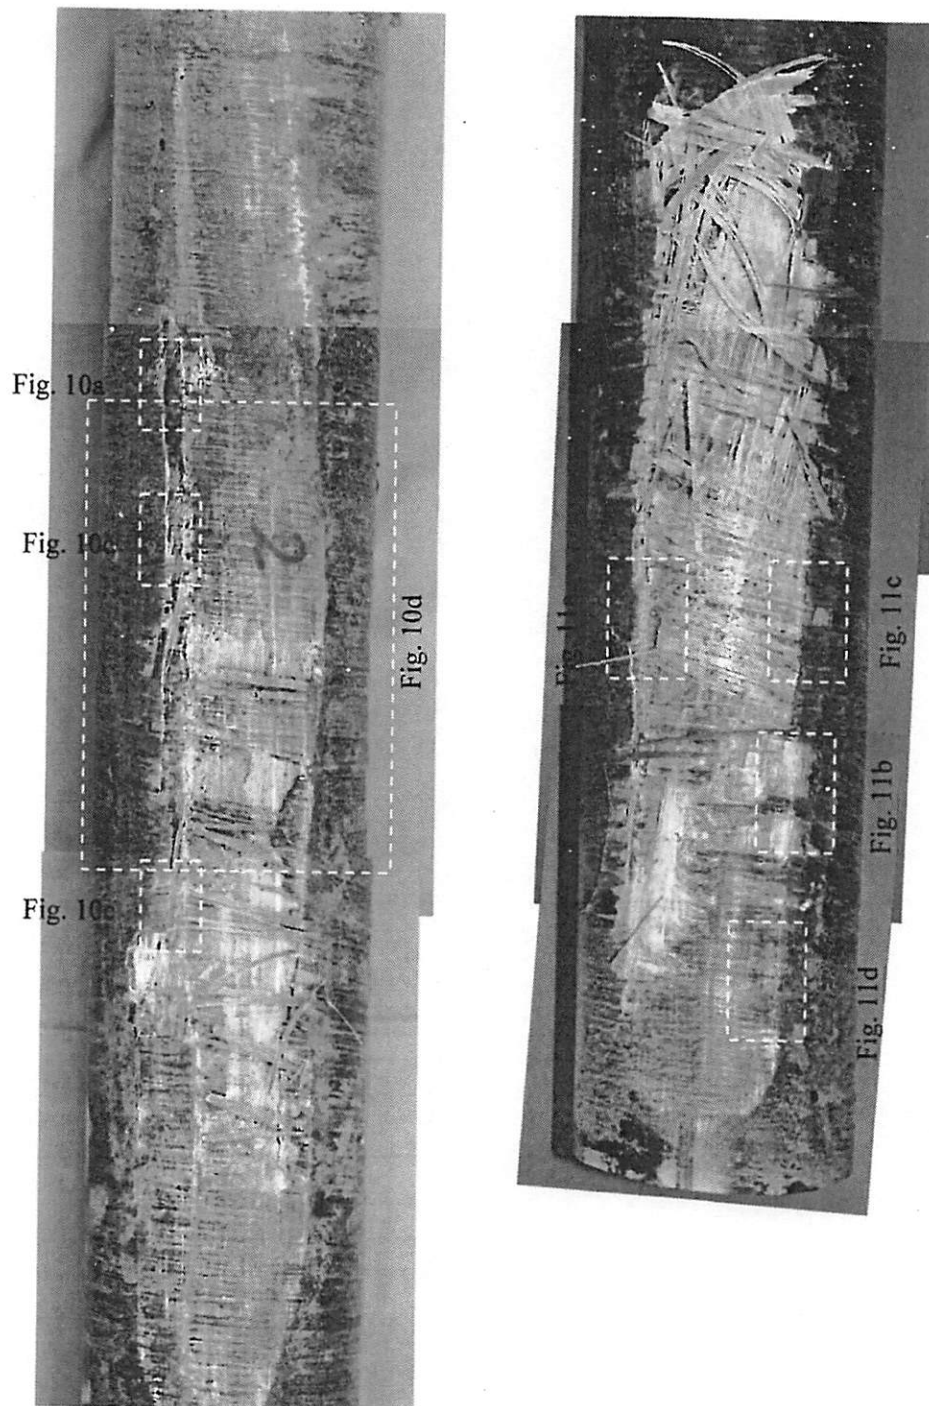
Figure 9. Damage induced by tooth (Tests #2 and 3).

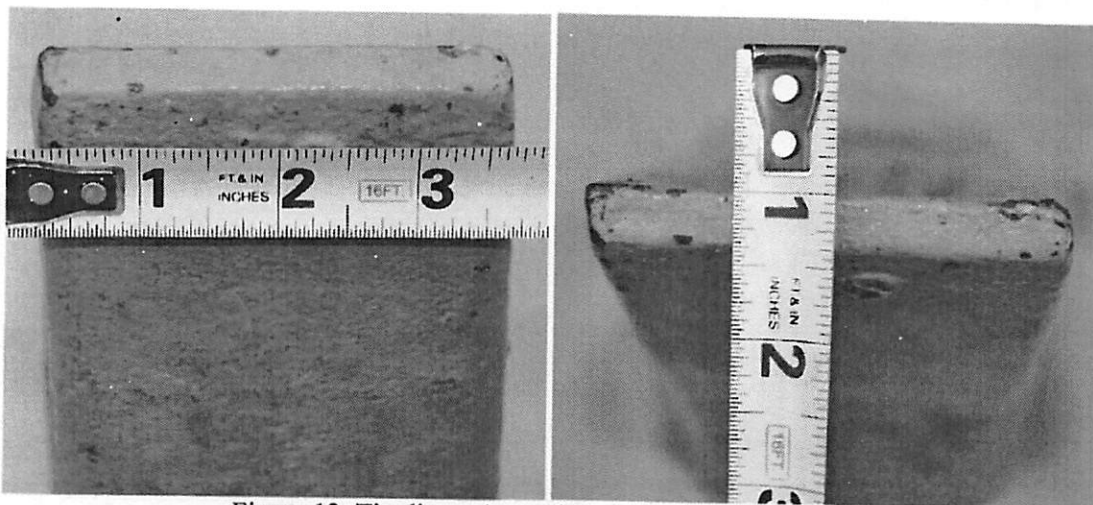
Figure 12. Tip dimensions of tooth employed in testing.

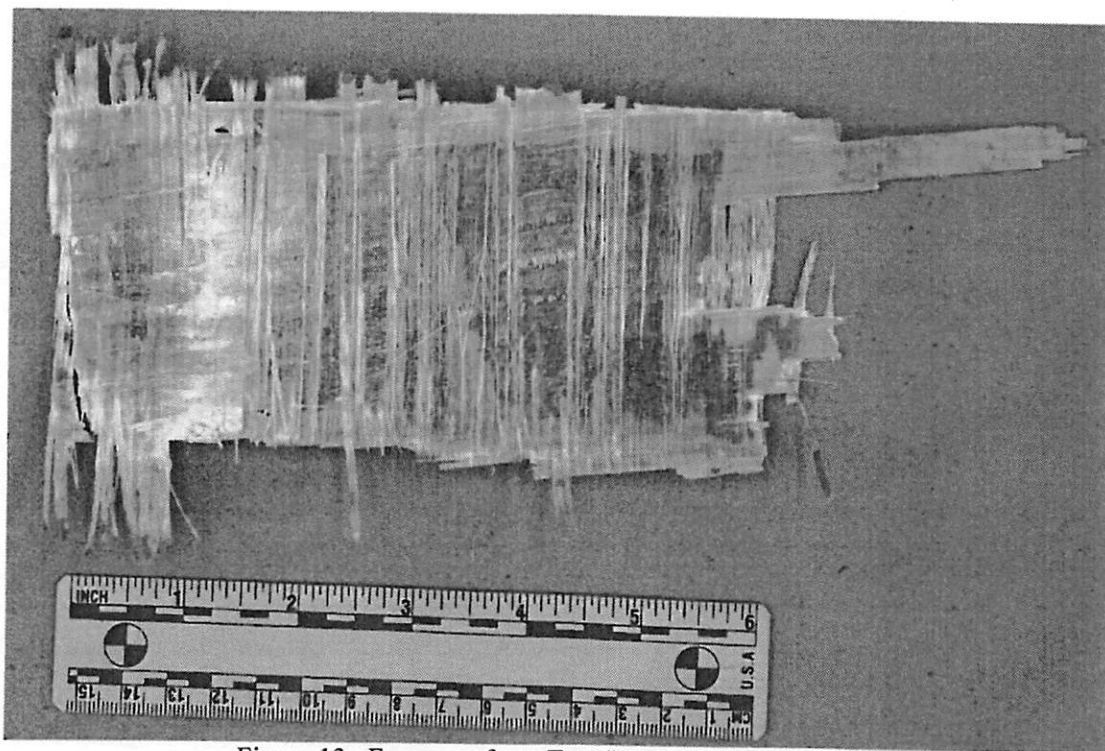
Figure 13. Fragment from Test #3 (showing underside).

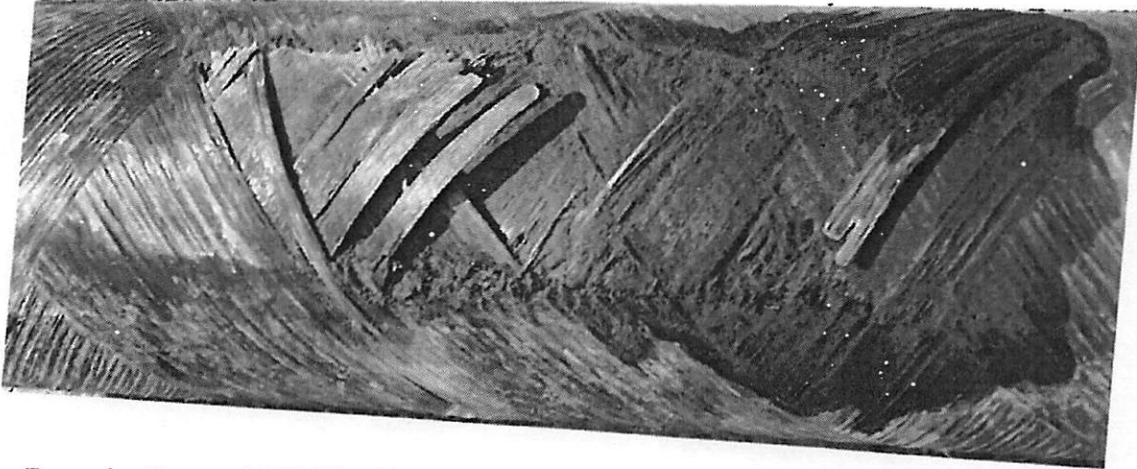
Subject Damaged FRP Pipe

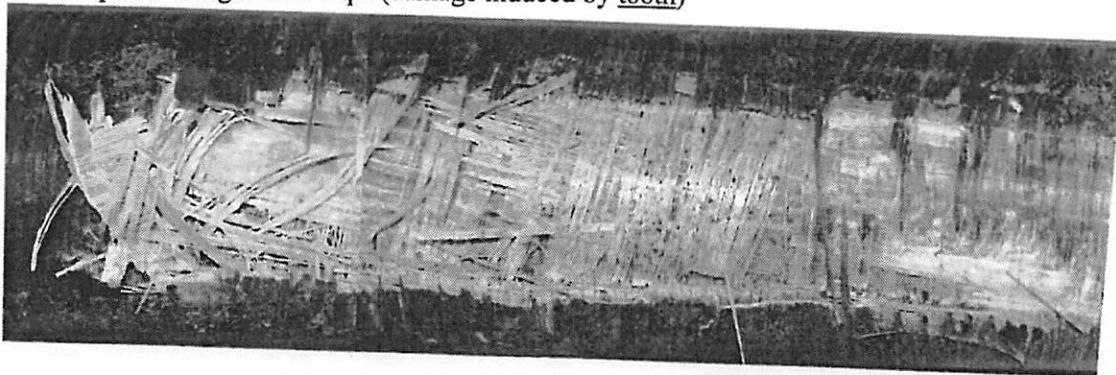
Exemplar Damaged FRP Pipe (damage induced by tooth)

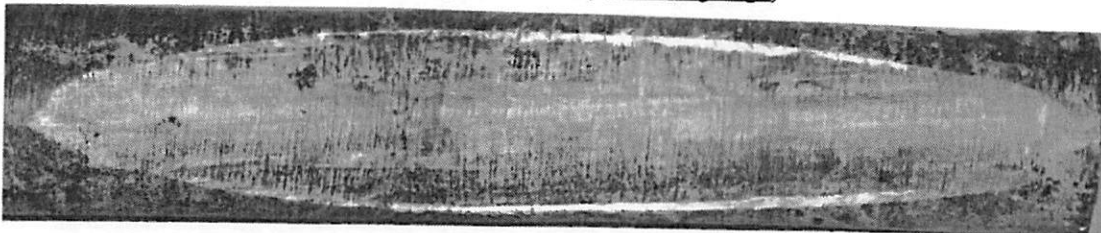
Exemplar Damaged FRP Pipe (damage induced by finishing edge)
